## Stabilization of a façade: a mix of intuition, science and political action

M. M. de Oliveira, R. Muñoz & C. C. Santiago  
*Federal University of Bahia, Salvador, Bahia, Brazil*

doi: 10.14575/gl/rehab2014/034

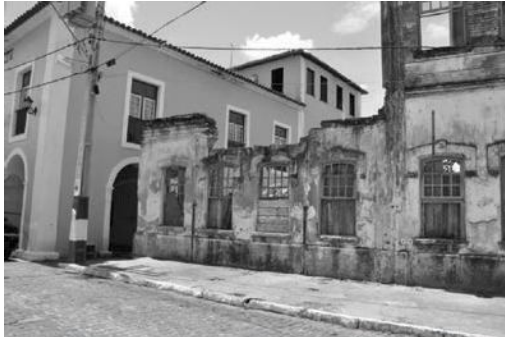
Figure 1. Left wing of the building.

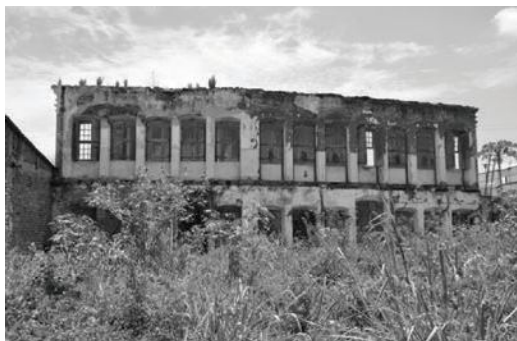
Figure 2. Central wing of the building, seen from inside.

The current situation of the property is embarrassing (Figs. 2-3). Abandoned, it had one of its side wings recovered and used as a commercial point, and the rest was left aside, to be consumed by the ruin. This has brought losses of major consequence to the image of the square, not only for the loss of volume of the building and its significance to the urban fabric, but also due to the fact of having one of their wings restored, contrasting grotesquely with a melancholic abandoned ruin.

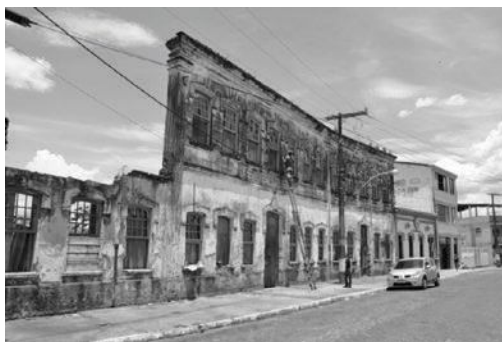
Figure 3. Situation of the building nowadays.

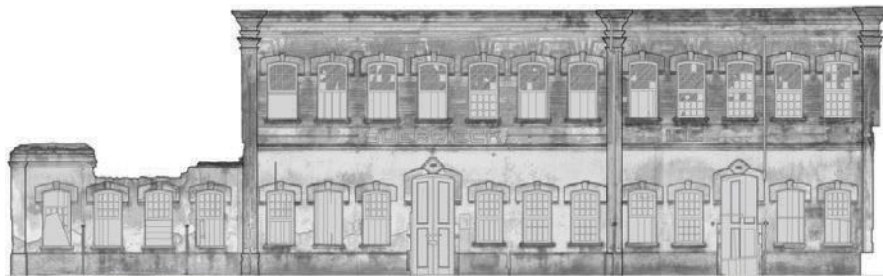
The photographs were rectified in PhotoModeler Scanner software, using at least three photos with the camera positioned at different angles from the façade and, preferably, one perpendicular and two inclined. The total number of frames in order to obtain an image with no perspectives varies according to the size of the façade, the area covered by each photography and eventual obstruction by objects. The result of the survey is shown in Figure 4.

Figure 4. Façade obtained from orthophotos.

Comparing the photogrammetric cadastral survey (most accurate) with the old register, it was observed that the total length of the façade, about thirty meters, and the height of the building are equivalent. The major differences were noted in positioning the upper and lower frames and in the detail level achieved due to the use of orthophotos. These photos, after rectification, also allowed the accurate mapping of the façade's damage, for preparing the consolidation project.

The photogrammetric survey has shown that the central façade is inclined, but it still stands because the center of gravity of the system remains within the middle third of the base. No one can, however, ensure its stability, without the necessary reinforcement, if there is a strong rain, especially with the vibration of frequent vehicle traffic.

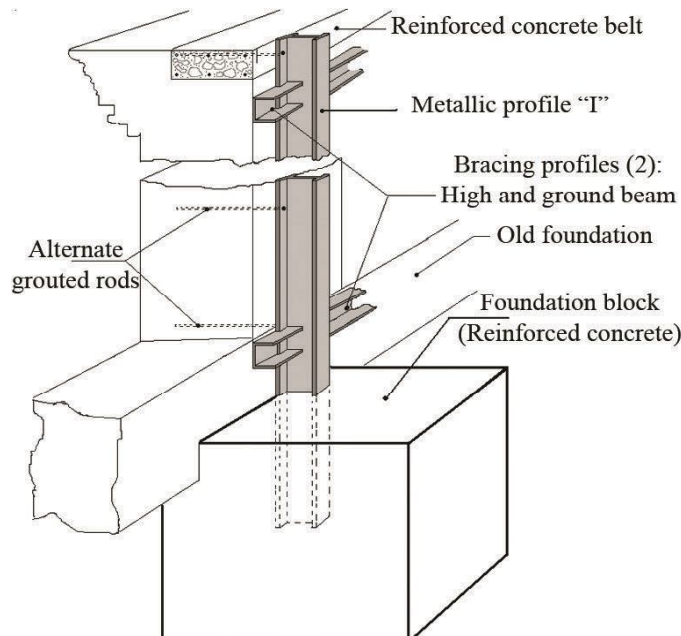
To prevent rotation and collapsing of the *façade*, it was proposed a system, consisting of metal pillars fastened to the *façade* with threaded rods fixed with epoxy resin by longitudinal steel beams (Oliveira, 2011) embedded in a block of reinforced concrete foundation. The walls shall also be fixed at a higher level with a reinforced concrete belt. The structural system is shown in Figure 5.

Figure 5. Croquis of the stabilization process proposed (intuitive conception).

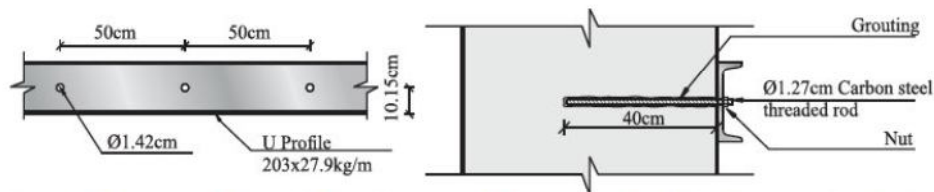
The profiles will be stuck in neutral axis fixed in the masonry by using carbon steel threaded rods one-half inch in diameter, fastened with nut. In the thinner walls, the hole for fixing the profile should have, as a minimum, 30cm depth. The fastening system of the masonry profile is shown in Figure 6.

Figure 6. Locations of holes in the fastening system of the masonry U profile and cross section showing the attachment.

The bracing beams will be arranged in three levels: at the level of the main front cornice, below the level of the first pavement and as a ground beam. The profiles used will be type U203x27.9kg/m, which attends the deformation parameter, the bending moment and shear in both directions (X axis and Y axis).

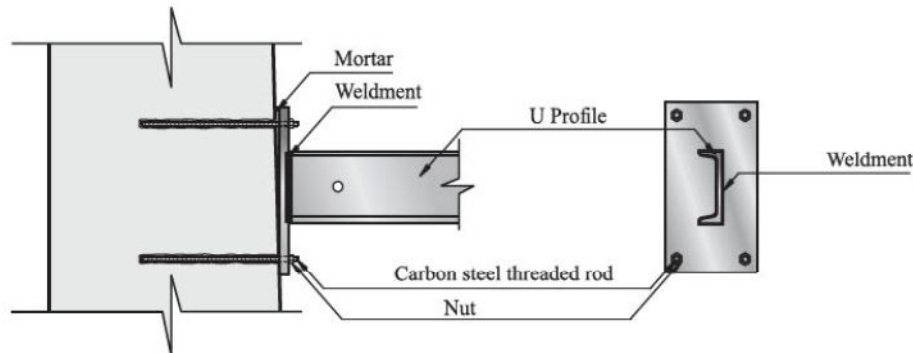
The connection of the final part of the corner profile to the masonry will be as shown in Figure 7. The bar will be welded to a metal plate, held by stainless steel threaded rods and nuts. The irregularity in the support of the plate to the masonry will be resolved with the use of mortar.

Figure 7. Support of the end of the U-profile in masonry.

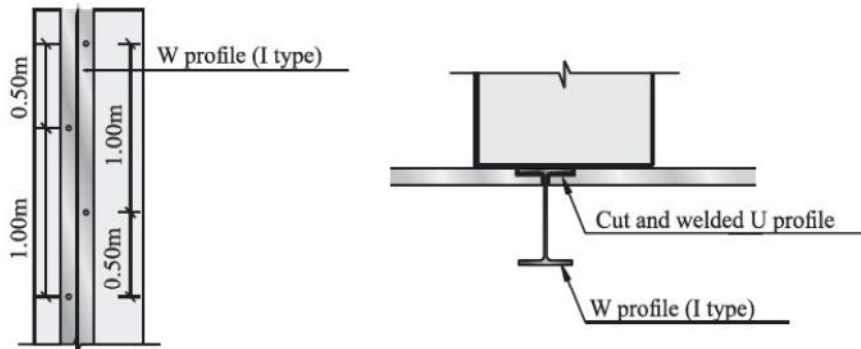
The metal pillars proposed, calculated to flexion-compression, in W-profile (Type I) 360x79kg/m, will be grouted in the masonry throughout its length with threaded rods of carbon steel, half an inch in diameter, fastened with nut and set in concrete bases. Any gaps between the rectilinear profile and uneven walls should be filled with cement mortar 1:3 to prevent water penetration, as well as the best adjustment of the piece on the wall. The connection of the pillars to the bracing beams is shown in Figure 8.

Figure 8. Spacing of the mounting holes in the masonry pillar and detail, in plan, of the U section profile in the vicinity of the pillar and its weld.

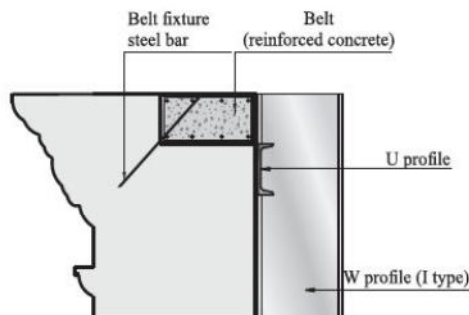
The project also provides the placement of reinforced concrete belts on the top of the masonry for clamping. The belts will be assembled longitudinally, with amended accrued irons pieces, and transversely, with 6.3mm diameter iron stirrups spaced 15cm. The belt shall be attached to the masonry with steel rebars that will penetrate the masonry 30cm (Fig. 9). The distance between these linkages is 50cm.

Figure 9. Detail of the belt for masonry.

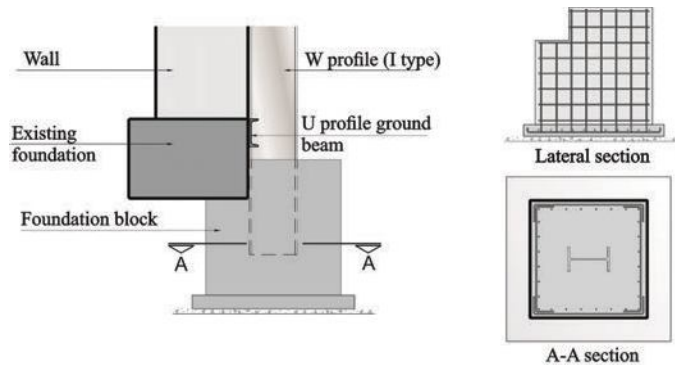
The pillars will be embedded in blocks of reinforced concrete cast on site, as shown on Figure 10. Since there is no data of soil and foundation existing in the vicinity of the ancient wall, the proposed scheme shall be revised. Soil conditions, verified after opening the pits, may recommend the application under the block of a concrete reinforcement slab or other form of deep foundation.

Figure 10. Iron reinforcement of the block.

The concrete block that will be used as foundation for the pillar should go forward a level below the plane supporting the foundation of the façade, with a steel mesh in the periphery to tighten the system. It is also proposed to place metal substructures welded between the pillars, running below the floor level, and shielded with concrete.
